**Täktominlahti Bay experimental restoration project as  
part of the CoastNET LIFE project 2019–2024:  
Final report on removal of *Myriophyllum spicatum* from  
a coastal lagoon by repeated mowing**

Metsähallitus case management: MH 229/2025: LIFE CoastNet LIFE, Täktominlahti, Hanko, final report on experimental lagoon restoration pilot project (C7)

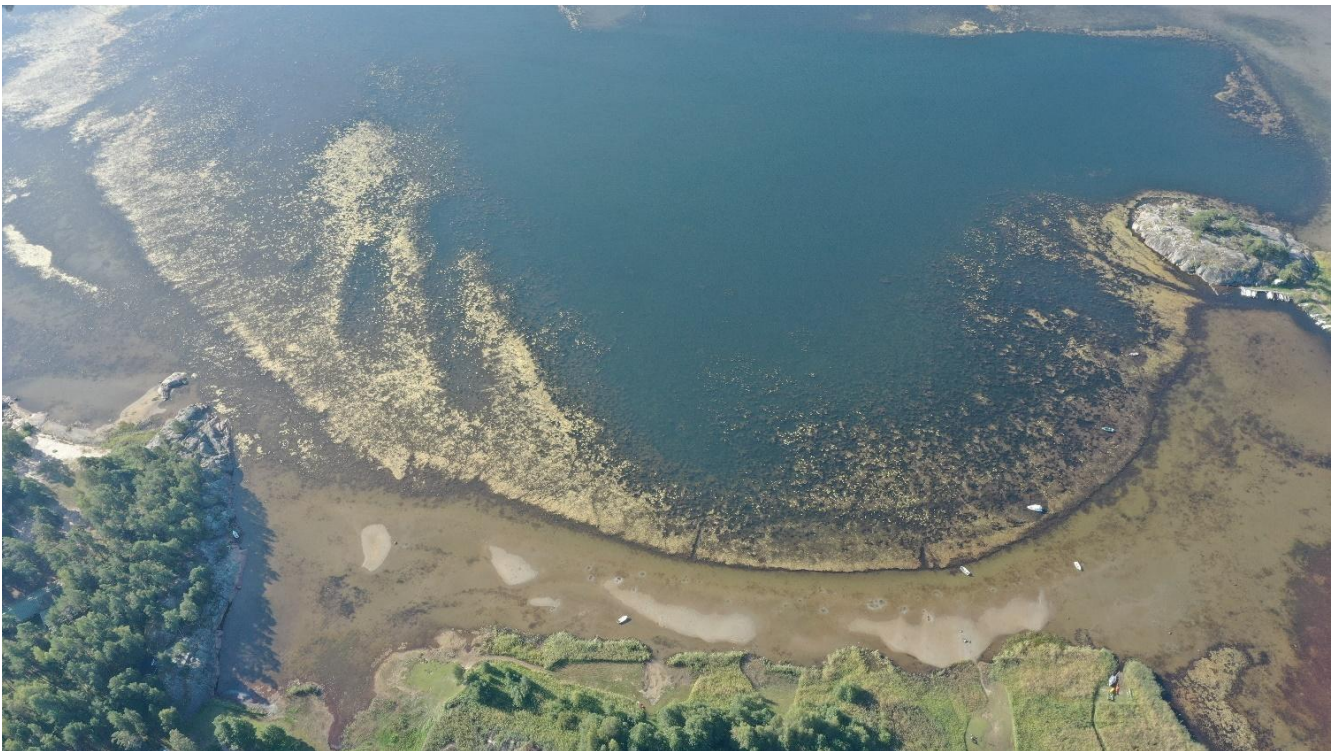
Cover photo: Täktominlahti Bay photographed from the air, 22 August 2020. The *Myriophyllum spicatum* zone reaches to the surface in some places. Photographer Ari Heinilä / Täktominlahti Management Association.

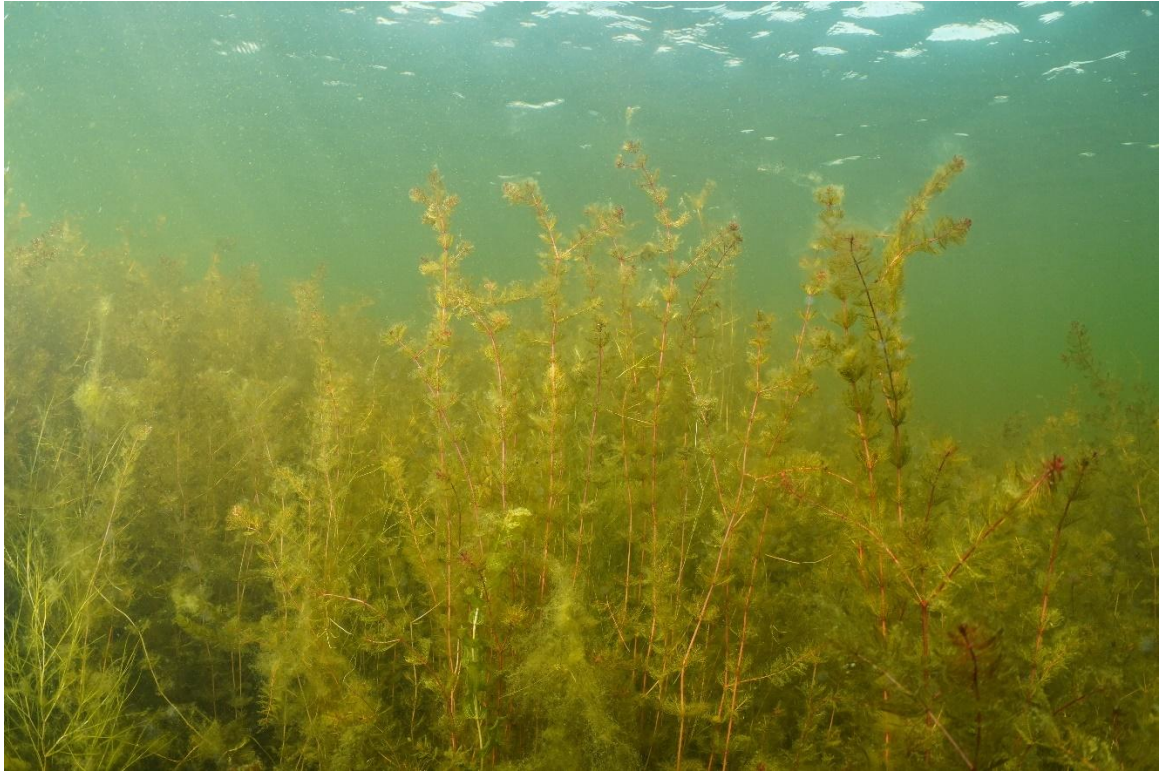
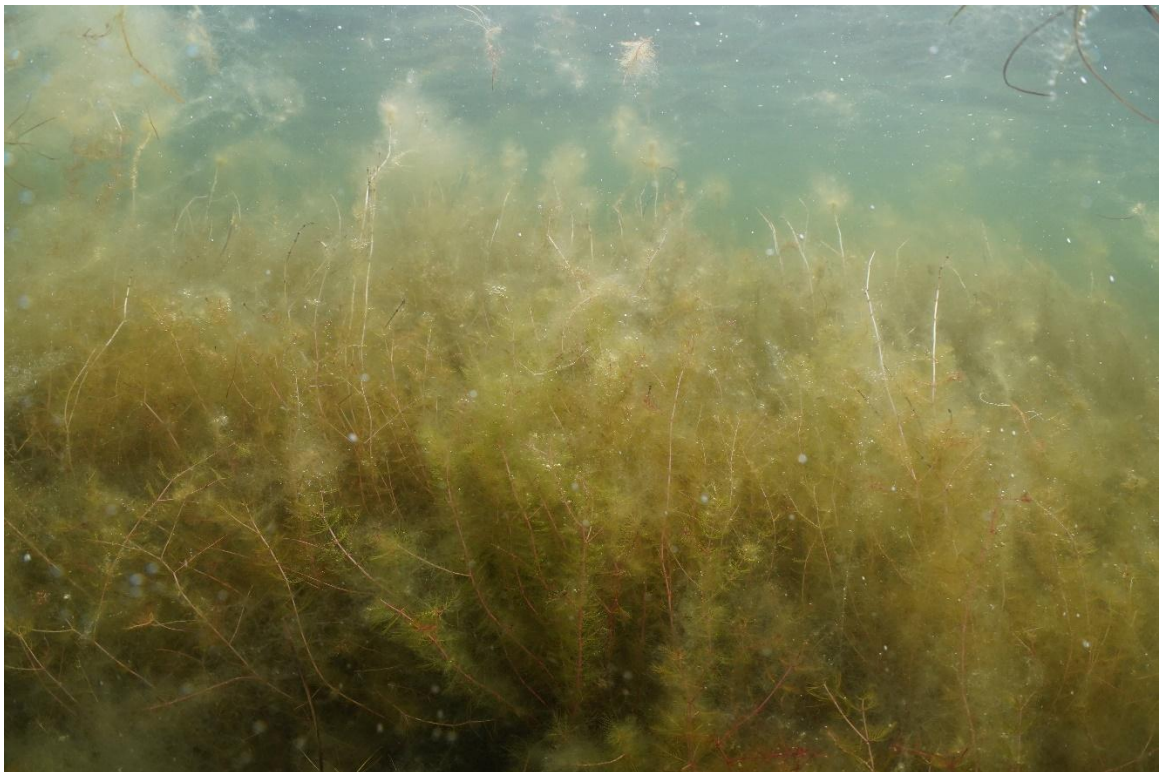
Figure 3. *Myriophyllum spicatum* photographed underwater in Tåktominlahti Bay. *Myriophyllum spicatum* forms dense vegetation that suffocates other plants under it (upper photo). Eutrophication in the bay has also caused an increase in *Cladophora sp.* They increase the accumulation of degradable plant material on the bottom and cause anoxia in the bottom. The *Cladophora sp.* drifting in the photo have caught on the dense *Myriophyllum spicatum* vegetation (lower image). Photos: © Juha Syväranta, Alleco Oy.

In Tägtominlahti Bay, *Myriophyllum spicatum* has taken over living space from original species (such as *Charales*, Figure 4), hinders recreational use of the bay (e.g. swimming, boating and fishing) and has disturbed water exchange in the bay. Decreased water flow has caused deterioration in water transparency and sediment – solid material transported and deposited by the water – has begun to accumulate on the sandy bottom. *Myriophyllum spicatum* is a perennial that withers after the growing season and its decomposing biomass has caused eutrophication on the bottom of the bay and on the shores around it. These are becoming overgrown as a result of the additional nutrients. Several bird, insect and plant species that are endangered at the national or regional level are found on the shores of Tägtominlahti Bay. The decomposing plant mass that accumulates on the shores during the autumn season is also a constant nuisance for residents living around the bay, as its removal is laborious and requires measures every year.

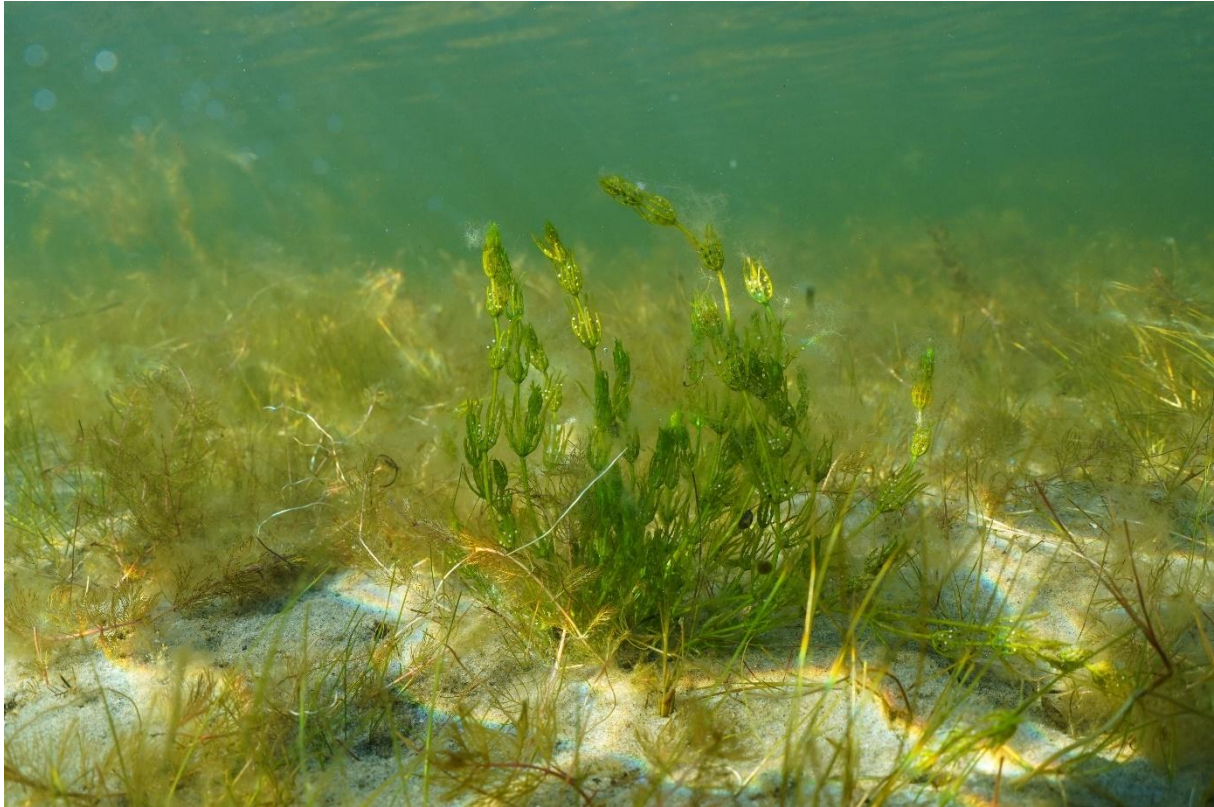
Figure 4. The sandy bottom in the shallow zone of Täktoimlahti Bay, where *Charales* species are still present. *Chara aspera*, *Chara baltica*, *Chara globularis* and *Chara virgata* were found in the monitoring transects. Dense and extensive Charales meadows can form in suitable conditions. Charales meadows are valuable habitats for many animals. They also effectively filter nutrients, which clears the water. Photo: © Juha Syväranta, Alleco Oy.

Despite the degraded state, *Charales* are still found in the shallow zone of the bay (Figure 4) and eelgrass around its inlet. *Zostera marina* is one of the keystone species in the Baltic Sea, providing shelter and food for many fish and small invertebrates. Both flats and gloe lakes (part of the coastal lagoon habitat type) and *Zostera marina* meadows have been classified as vulnerable habitat types in Finland's most recent national classification of threatened species (Kontula & Raunio 2018). *Charales* often thrive in shallow, soft-bottomed bays where they can form dense and extensive meadows. *Charales* meadows are valuable habitats for many animals. They also effectively filter nutrients, which clears the water.

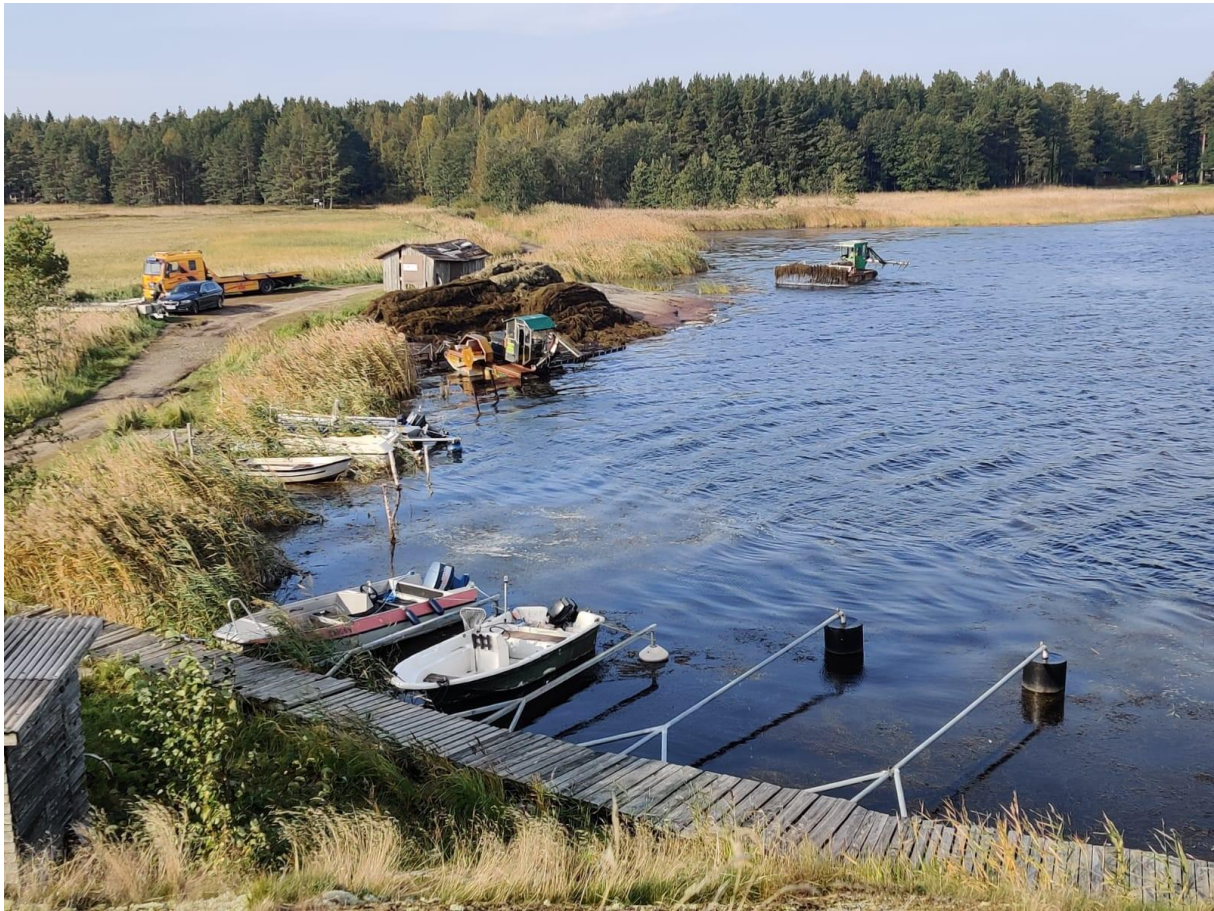
Figure 8. Mowing work with two machines in Täktominlahti Bay in 2020. The mowed *Myriophyllum spicatum* was laid on the shoreline rocks to dry before being transported to a nearby field. Photo: Asmo Paloniitty / Tmi Asmo Paloniitty.

Two mowing machines were used (Figure 8). One mainly performed the mowing, while the other was used to bring the mowed vegetation to shore. The total amount of mowing waste was approximately 60 cubic metres (m<sup>3</sup>) and the estimated mowing area approximately 8

hectares (ha) in size. The mowing waste was laid on the rocks at Kobben to dry for about a week, and later transported to a local farmer's field for use as fertiliser. The same further processing of mowing waste was repeated in the following years.

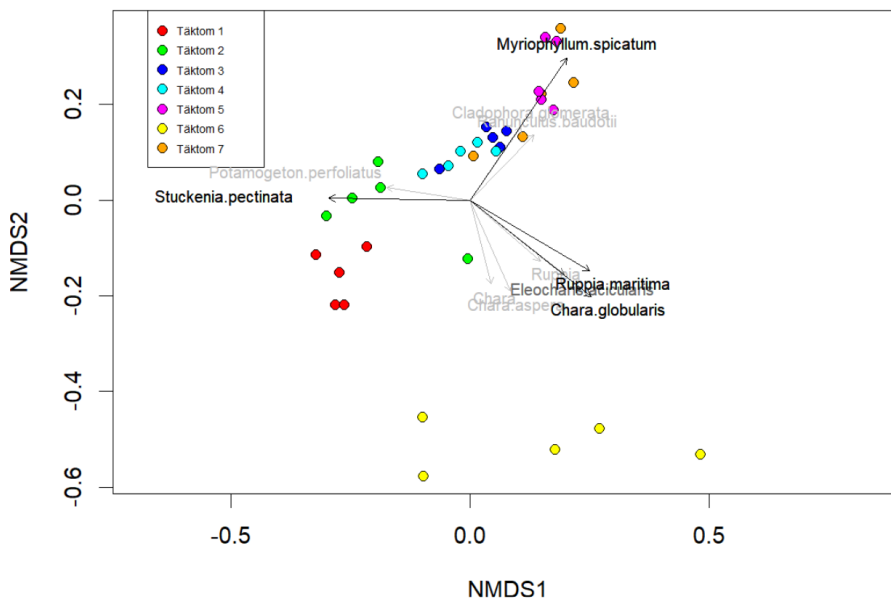
## Täktomin linjat

Figure 12. Täktom transects. Regardless of the year, there are clear differences between the transects. The least amount of *Myriophyllum spicatum* occurs in transect 6 (yellow dots) and the most in transect 5 (pink dots). More *Chara sp.* and *Ruppia maritima* are growing in transect 6 than in the other monitoring transects. Photo: Tytti Turkia / Parks & Wildlife Finland.

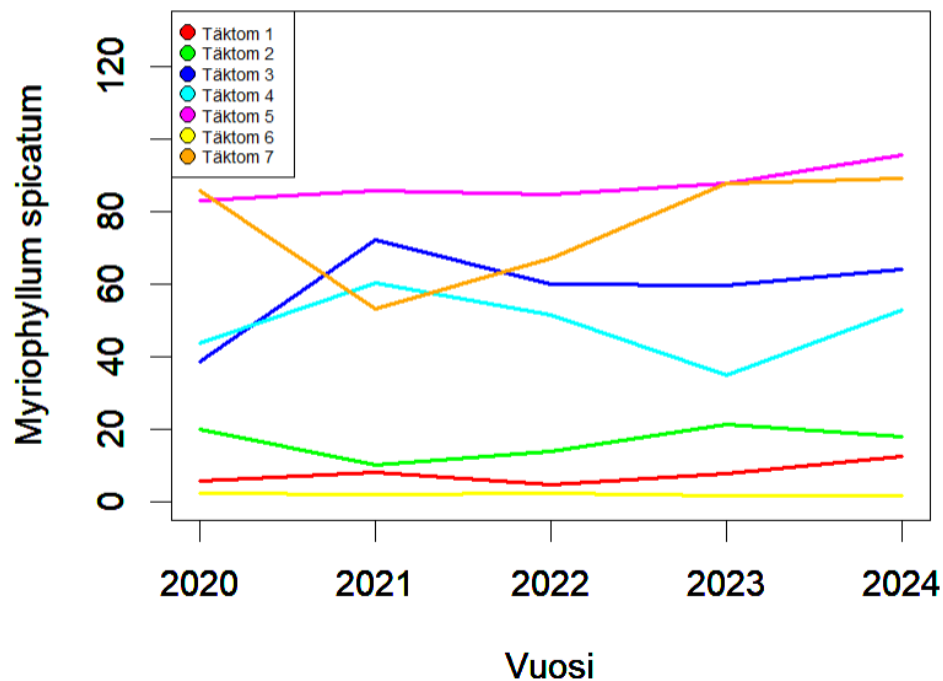
## Täktominlahden aikasarjat

Figure 14. Täktominlahti Bay time series. Development in the amount of *Myriophyllum spicatum* in the monitoring transects in 2020–2024. Repeated mowing does not appear to have impacted the amount of *Myriophyllum spicatum* in the monitoring transects. Photo: Tytti Turkia / Parks & Wildlife Finland.

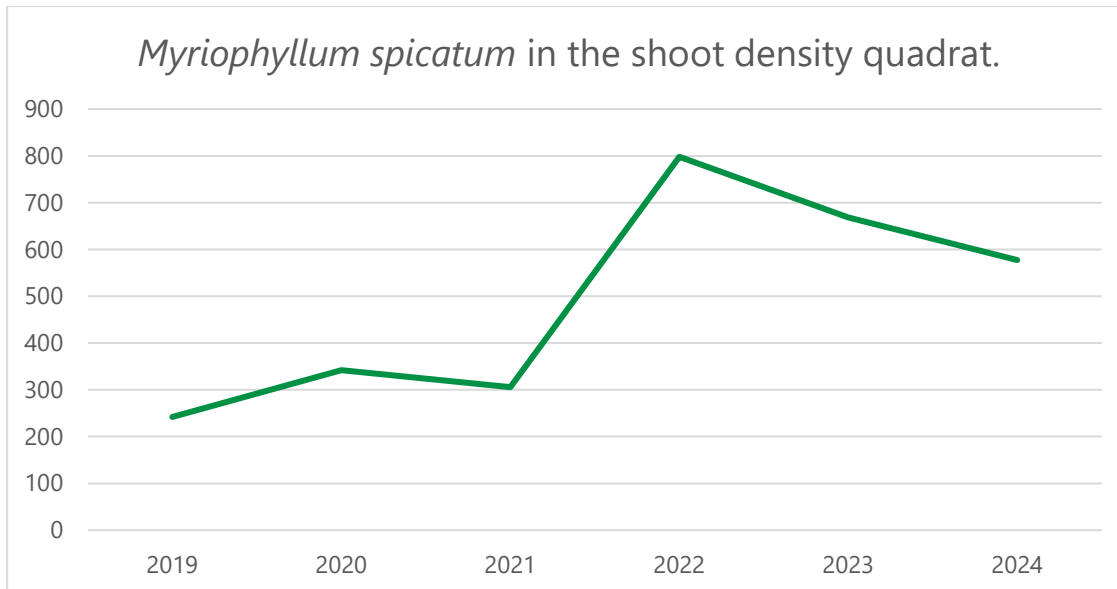
Figure 15. Development of the number of *Myriophyllum spicatum* shoots in the standardised monitoring quadrat in 2019–2024. The number of shoots increased during the monitoring period in 2022 and then began to slowly decrease. Photo: Tytti Turkia / Parks & Wildlife Finland.

A shoot density quadrat (1 m<sup>2</sup> in size) was randomly calculated at N59,833658 E23,089656 (Figure 5). The depth of the quadrat was 1.7 metres, and it was located in the dense *Myriophyllum spicatum* vegetation characteristic of the shore. The number of stems/shoots inside the quadrat were counted. It was established on 24 August 2019, and there were 242 shoots inside the shoot density quadrat in 2019 (Figure 15).

A standardised shoot density quadrat was located outside the monitoring transects (Figure 6), and this was used to count the number of *Myriophyllum spicatum* shoots annually. The time series in the shoot density quadrat differs from the time series in the monitoring transects. The shoot count remained fairly stable in 2019–2021, increased in 2022, and then began to slowly decrease while still remaining at a higher level (Figure 15). None of the dive transects showed the same trend in the amount of *Myriophyllum spicatum*.
